City of Detroit
Department of Recreation Performance Audit
Exhibit 3 – Edmore-Marbud Playground

Overall Evaluation – Poor Condition

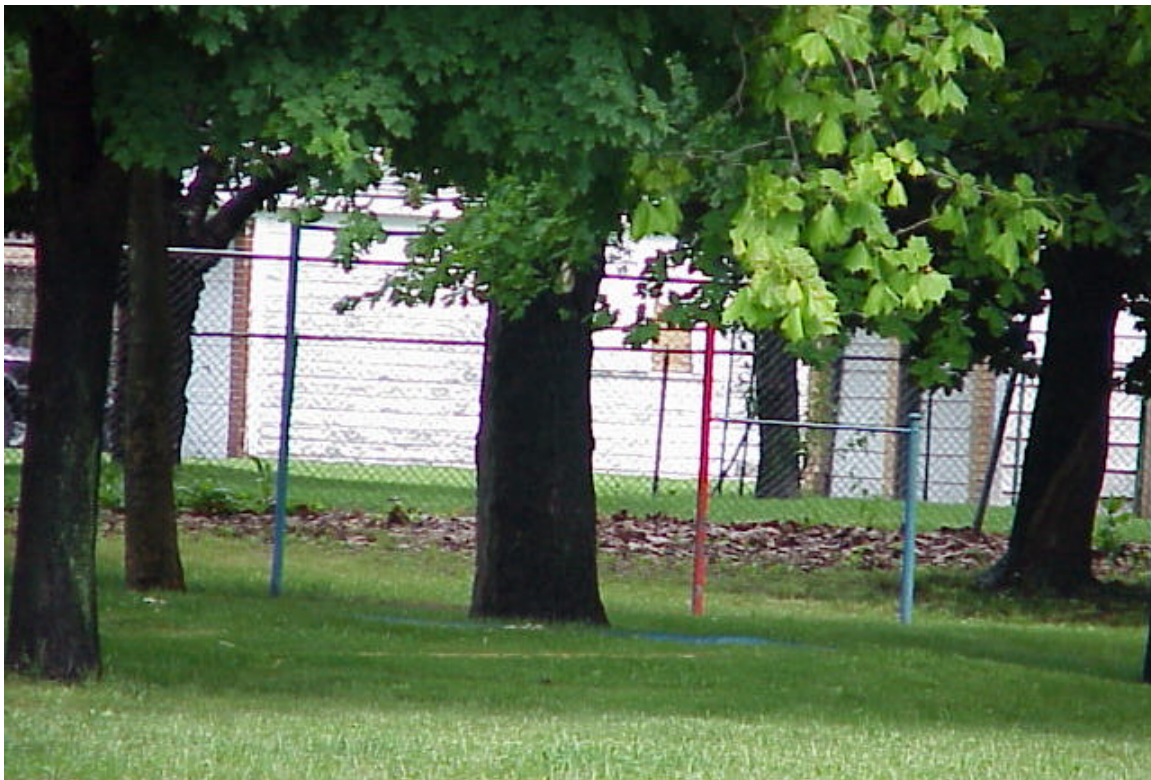
Overgrown tree branches interfered with and were intertwined with play equipment.

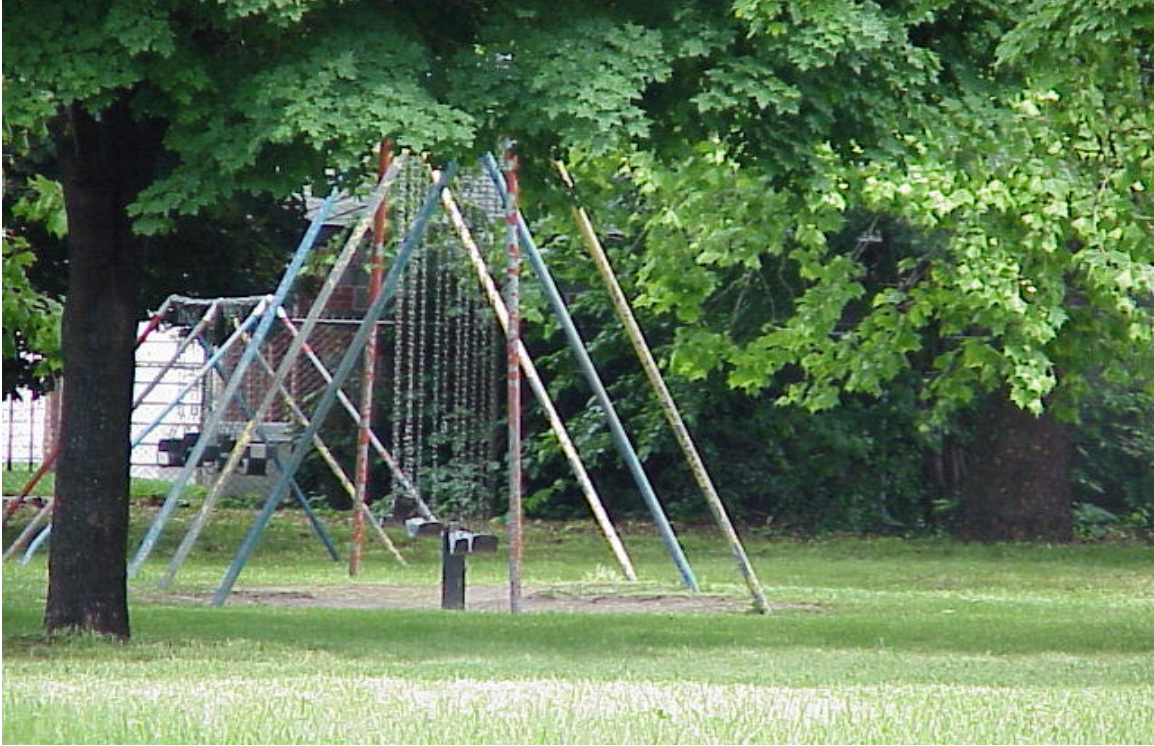
Swing sets with chipped and peeling paint. Concrete area around poles exposed. No shock-absorbent materials beneath swings. Over-grown branches intertwine with play equipment.

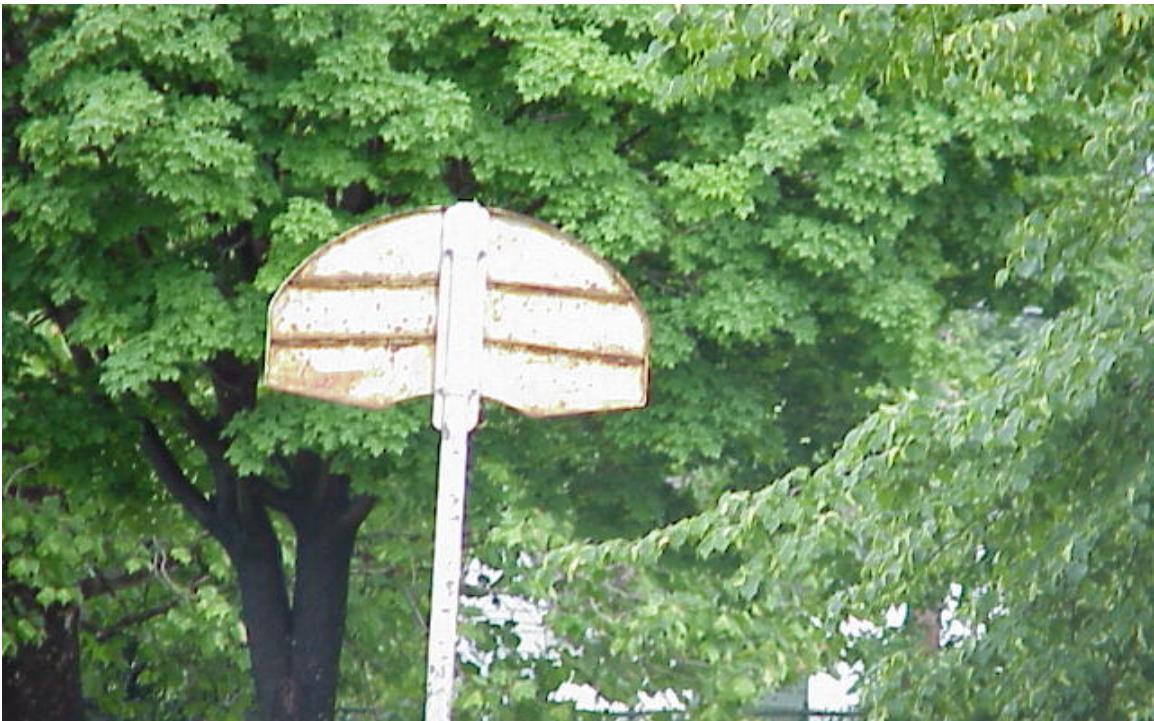
Rusty basketball pole with no hoop or net. Trees overgrown into the basketball court.
